The Threat to Pipeline Integrity from Soil Corrosion

Umair Niaz, Bureau Veritas, UAE, M Hussain, University of Wollongong, Australia

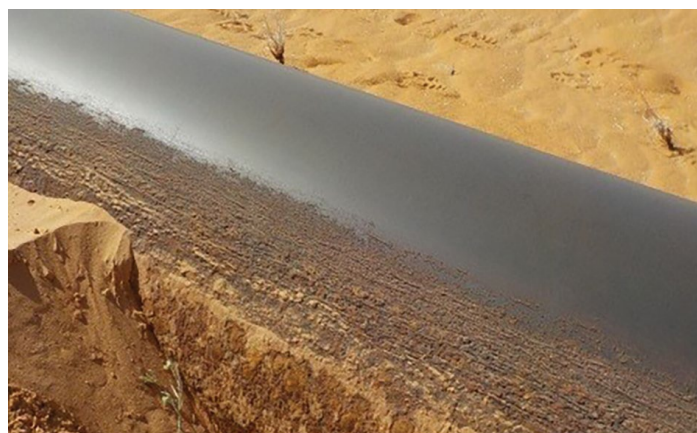
A routine visual inspection of an above ground pipeline network revealed that at a number of locations external corrosion in the form of general scaling (surface oxidation) and localised pitting was starting to occur (see photos 1a and 1b). The pipelines were constructed of API 5LC - UNS-S31803, using grade LC65-2205, suitable for Maximum Allowable Operating Pressure (MAOP) of 65 bar and a design temperature between -29 to 90 C. The line was externally coated with 3 Layer High Density Polyethylene and cathodically protected using an impressed current cathodic protection system. It thus was decided to further inspect, and then propose recommendations to prevent failures in the future for the damaged/rusted locations.

Photos: 1a (above) shows pipe sections covered with sand, 1b (below) shows pipe sections developing pits

- The pipeline was laid over moisture containing soil, and part of the pipeline was found to have been buried due to wind. Soil analysis revealed nature of the soil in close proximity to these sections as highly corrosive. Therefore soil corrosion was very likely to occur. A matrix of the corrosion risk factors High, Medium and Low of soil backfill were analysed following the guidance in BS EN 16299:2013 diagram [5], and API 651 [6] and shown in Table 4 and Figure 2.

- Effective coating programme should be maintained in order to avoid any kind of external corrosion.
- Internal corrosion direct assessment (ICDA) process to assess and manage the internal corrosion threats on a dry natural gas pipeline in line with NACE standard practice SP 0206-2006 (section 10.6.3) [9].

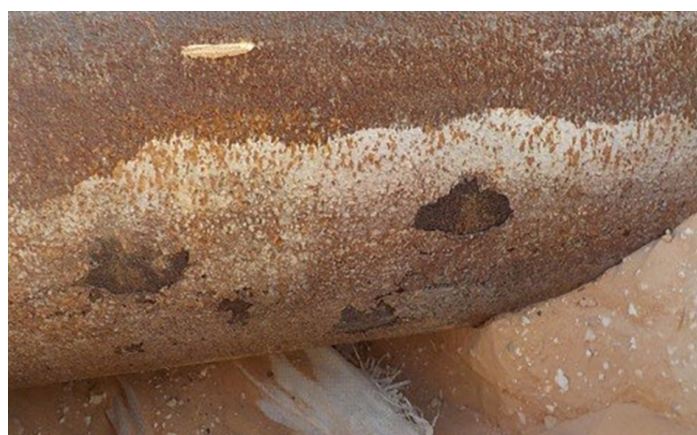
- General scaling (surface oxidation)
- Localised areas affected by presence of chlorides/gypsum and in particular, wetted soil conditions
